**Petrochemical
Industries Design
Equipment & Parts
Manufactring Co.**

Project Summary

Fabrication of PTFE Lined Stack

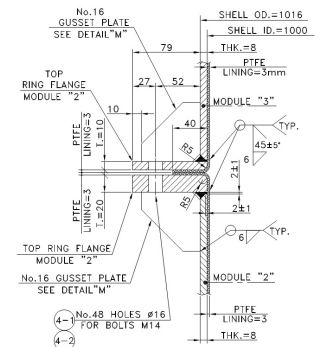
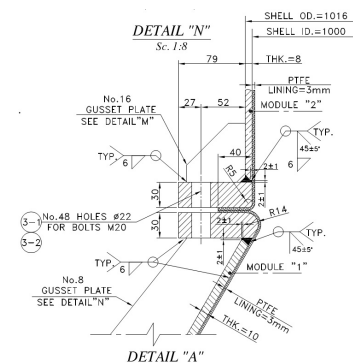
This STACK is specially designed to resist corrosive environment. PTFE lining is loose, thick and fully resistant to corrosion. It is suitable for almost all corrosive fluids within the temperature range from -50°C to +230°C. Due to the inertness of PTFE to

almost all chemicals and solvents, it acts as an effective barrier between the chemical and steel, thus not only protecting the equipment, but also safe guarding working environment.

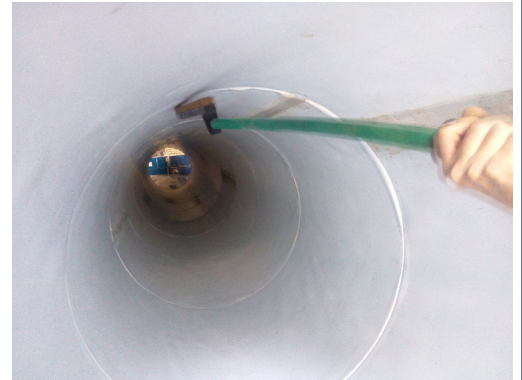
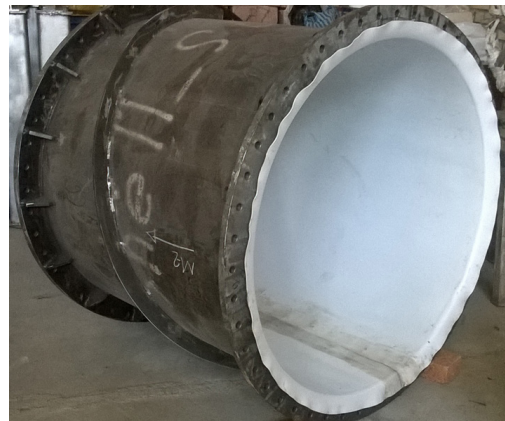
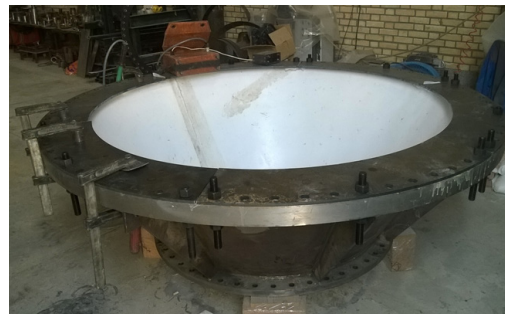
In order to Properly stick/attach PTFE layer to internal surface, the length of the cylinders should be shorter than 1 meters, while the stack in this project is 10 meters long. Therefore, the cylinder is divided to 10 parts and were joined to each other using flanges. PTFE lining of conical and flanged parts is a complicated work and should be done with care and experience.

Lining integrity is critical, even very small micro cracks or defects can allow flow media to reach the body material. To inspect the lining, hydrostatic and Electrostatic test should be done on the equipment. In electrostatic test equipment is subjected to 25KV nondestructive spark test. The test is carried out as specified in ASTM F 1545. This test is carried to detect any defects, cracks pin holes in the liner. Spark occurs which is audible and visible if there is any defect in the lined part. Stack operates at Atm. Pressure so chances of leakage from bolted connection is very low, however the stack was air tested at 1.5 bar after assembly of segments together.
